IMPOUNDMENT 2 LINER INSTALLATION AND INSPECTION

**American Cyanamid
Superfund Site
20 Polhemus Lane
Bridgewater, NJ**

**213982.09
Wyeth Holdings Corp
August 21, 2012**

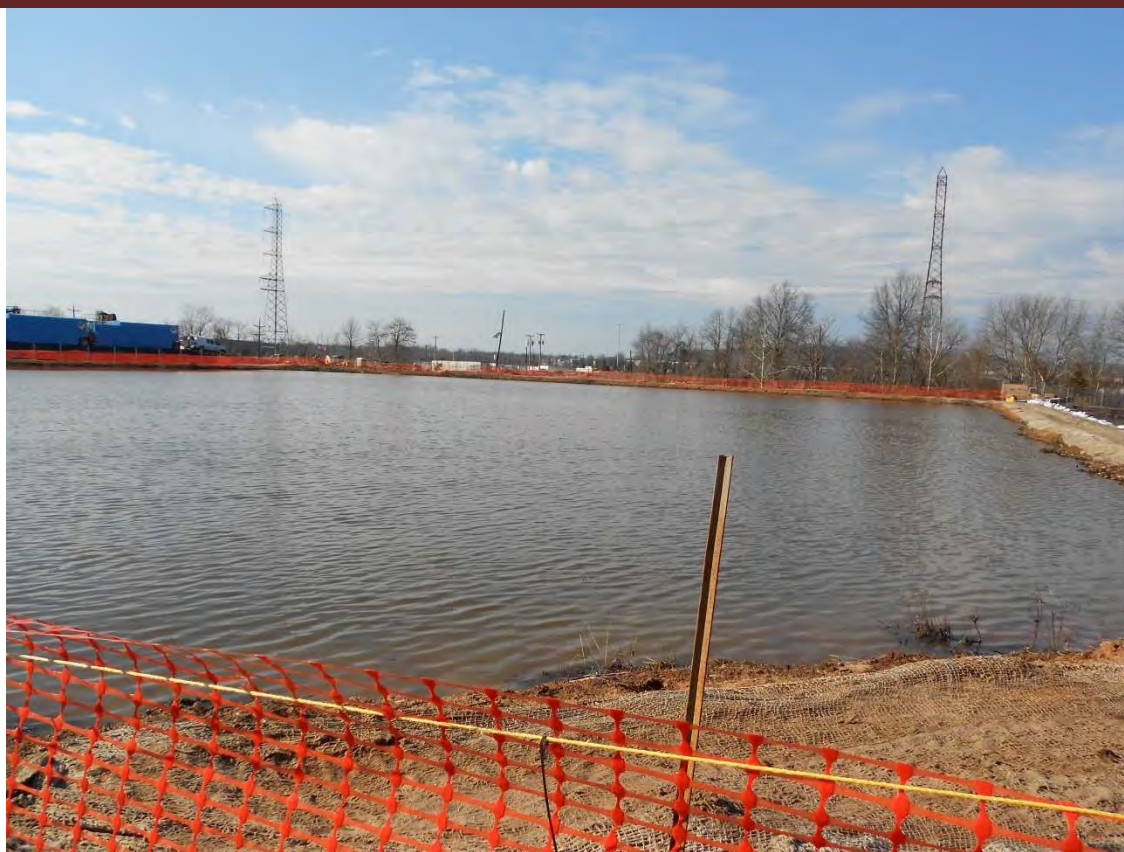
Photograph 1: February 27, 2012 – View of Impoundment 2 from southeast corner before installation of cover.

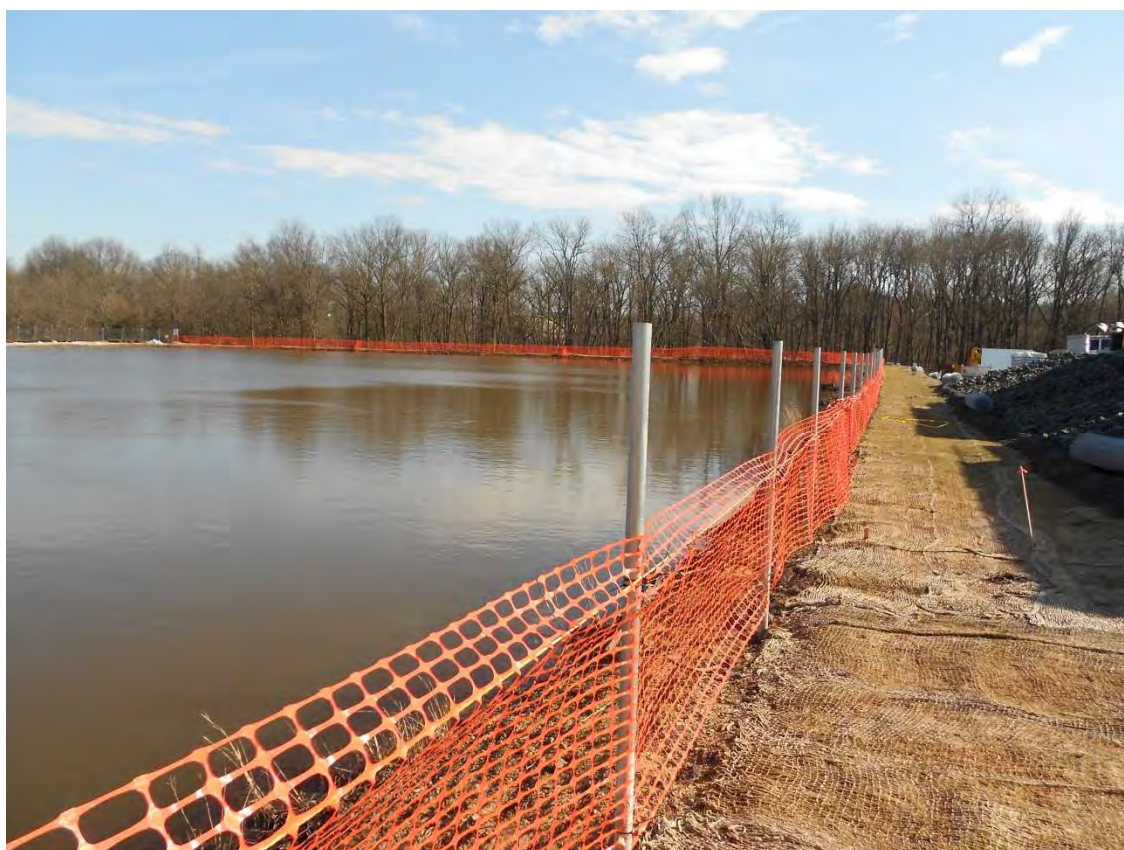
Photograph 2: February 27, 2012 – Temporary construction fencing used to secure area during construction.

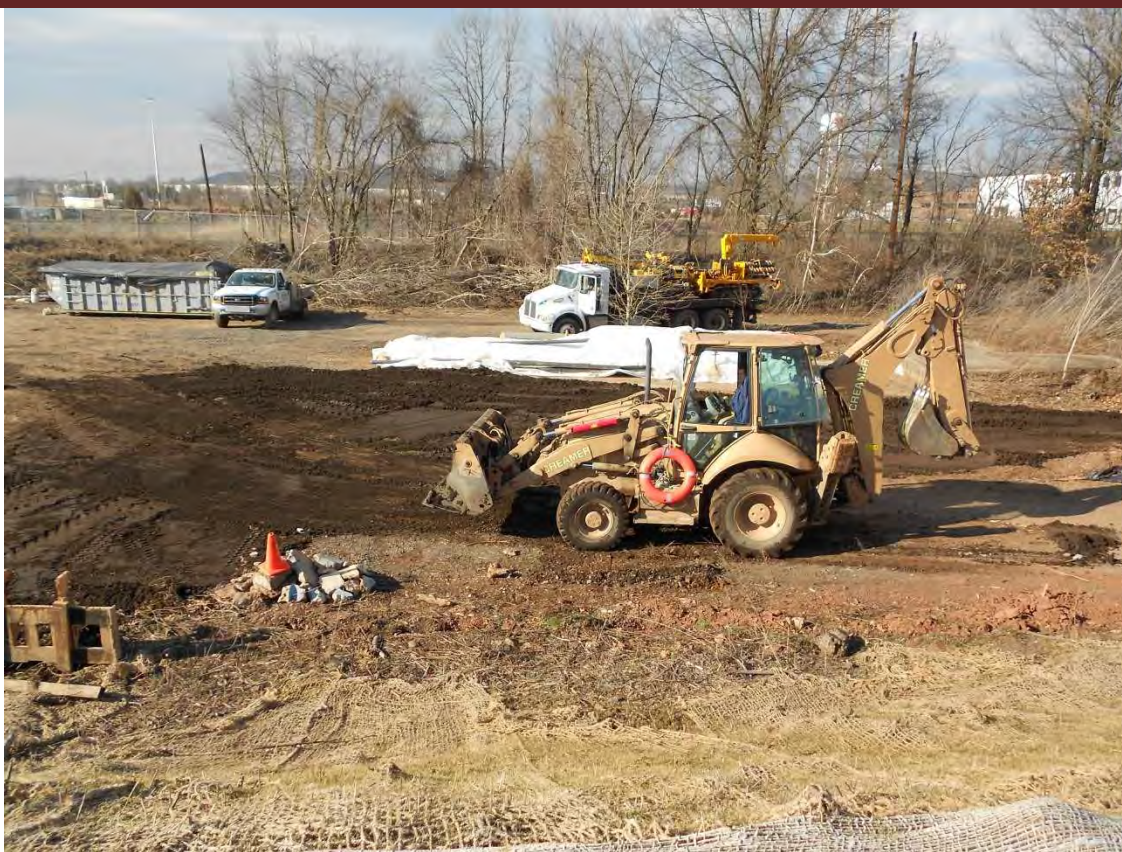
Photograph 3: February 27, 2012 – Preparing staging area north of Impoundment 2

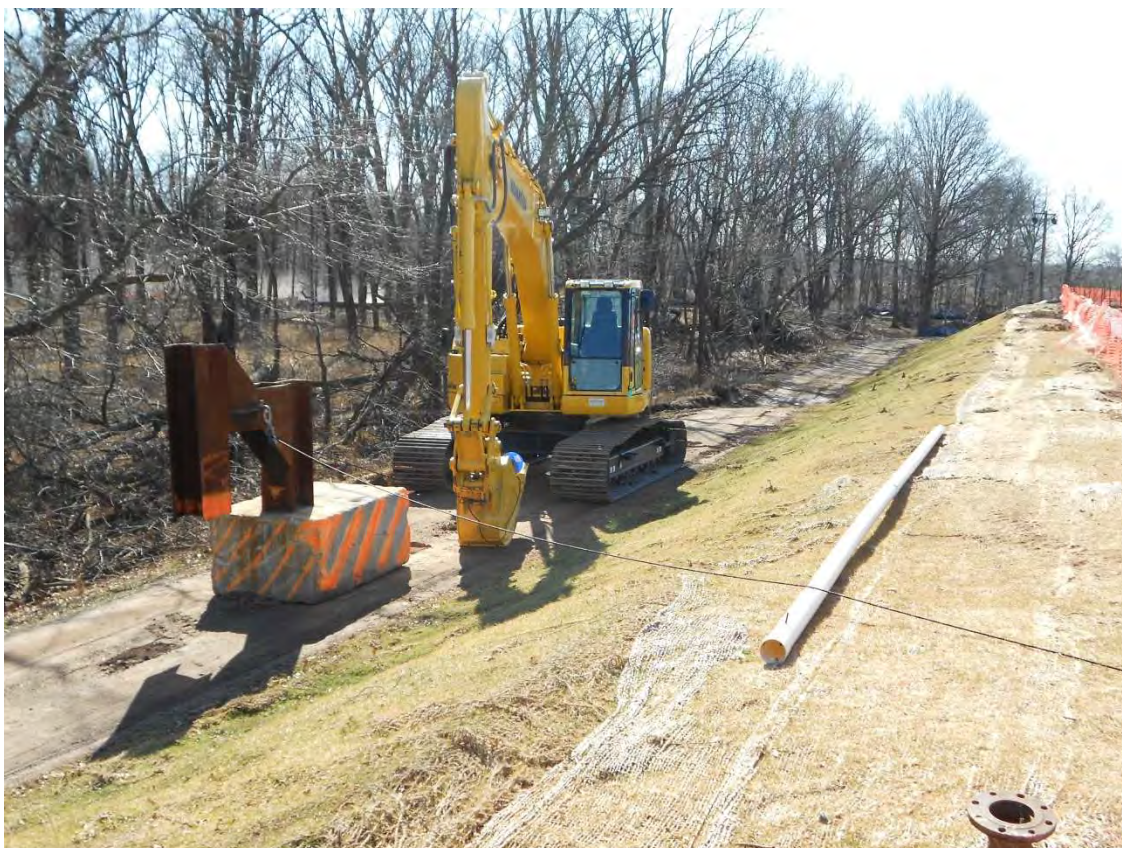
Photograph 4: February 28, 2012 - Excavator and cable anchor used to deploy panels.

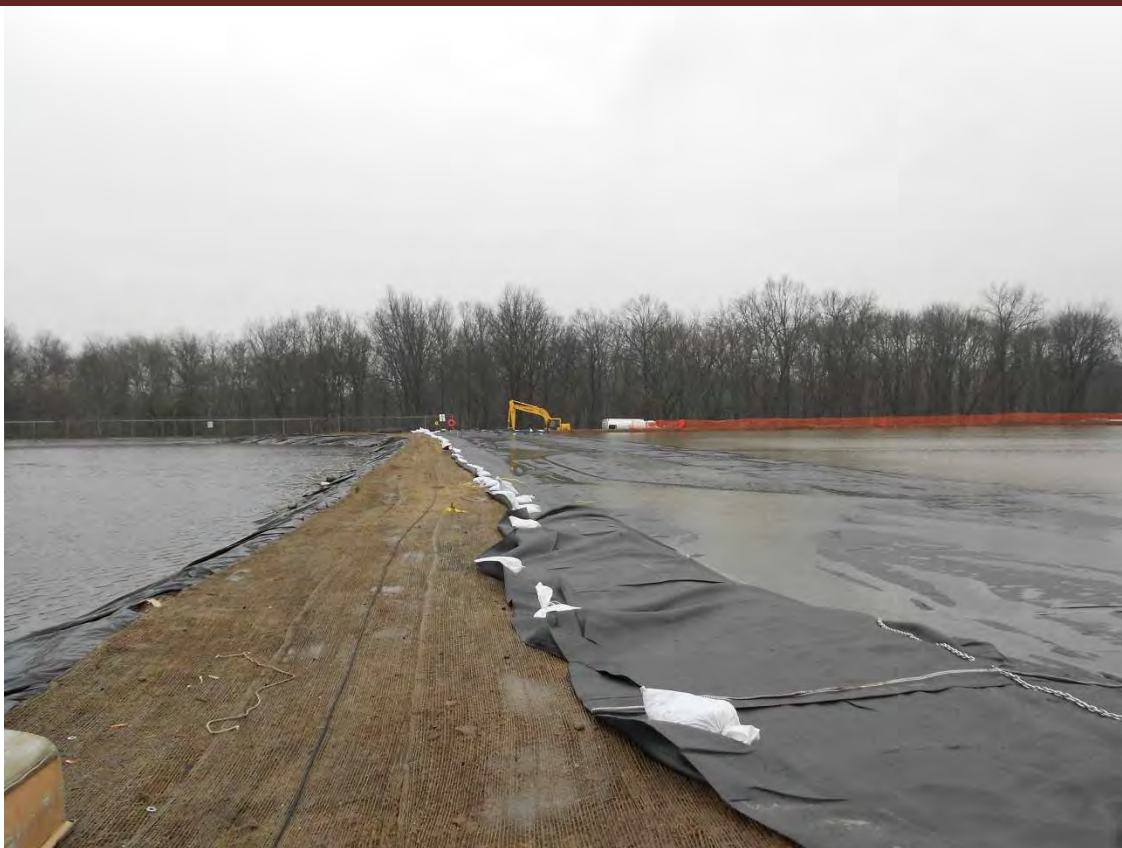
Photograph 5: February 29, 2012 – Deployment of first panel along eastern edge of Impoundment 2. Impoundment 1 is visible to the left.

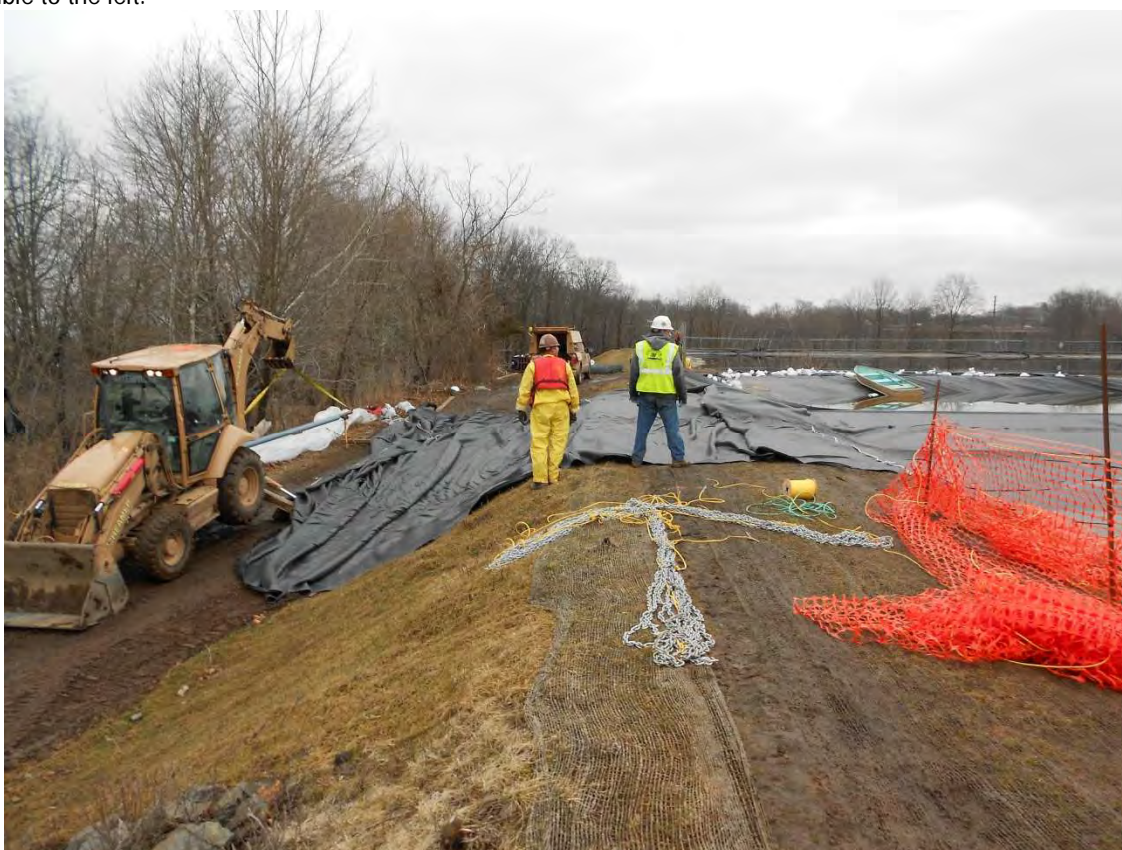
Photograph 6: March 1, 2012: Deployment of second panel from north side of Impoundment 2.

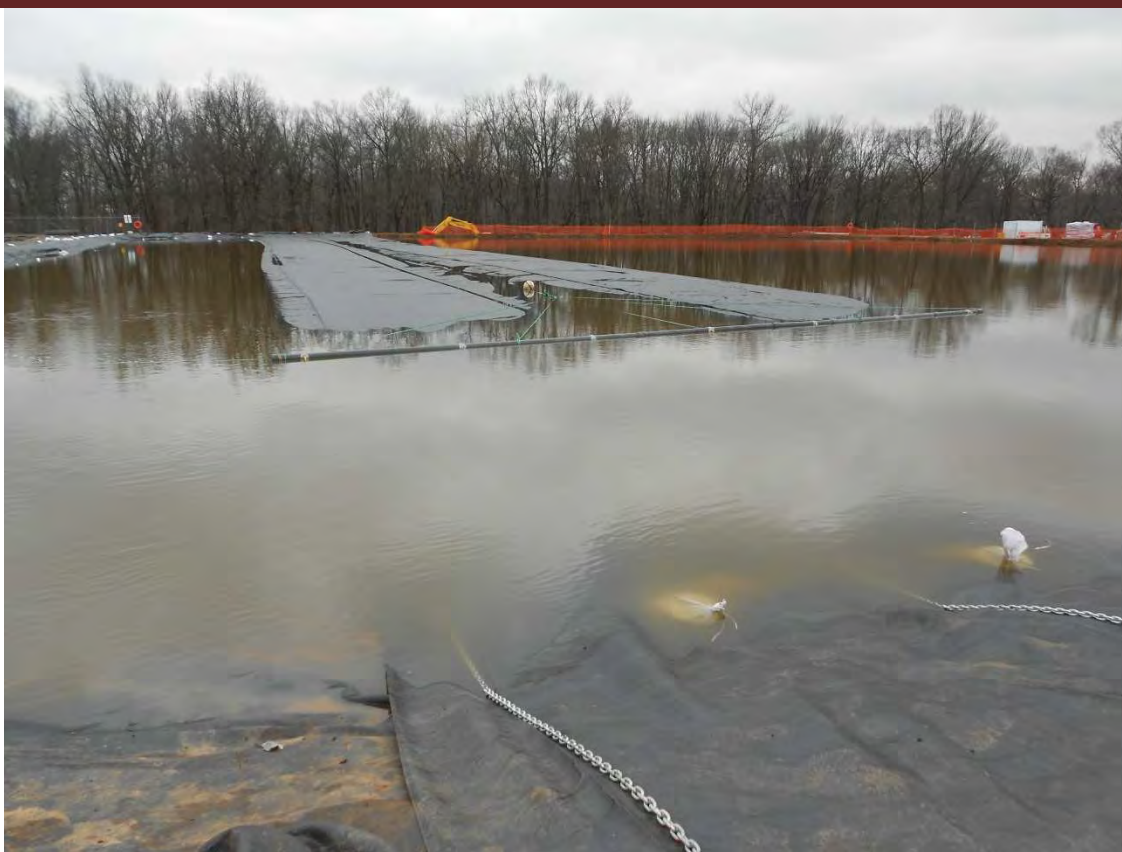
Photograph 7: March 2, 2012 – Placing ballast chains and stone bags used to sink second panel.

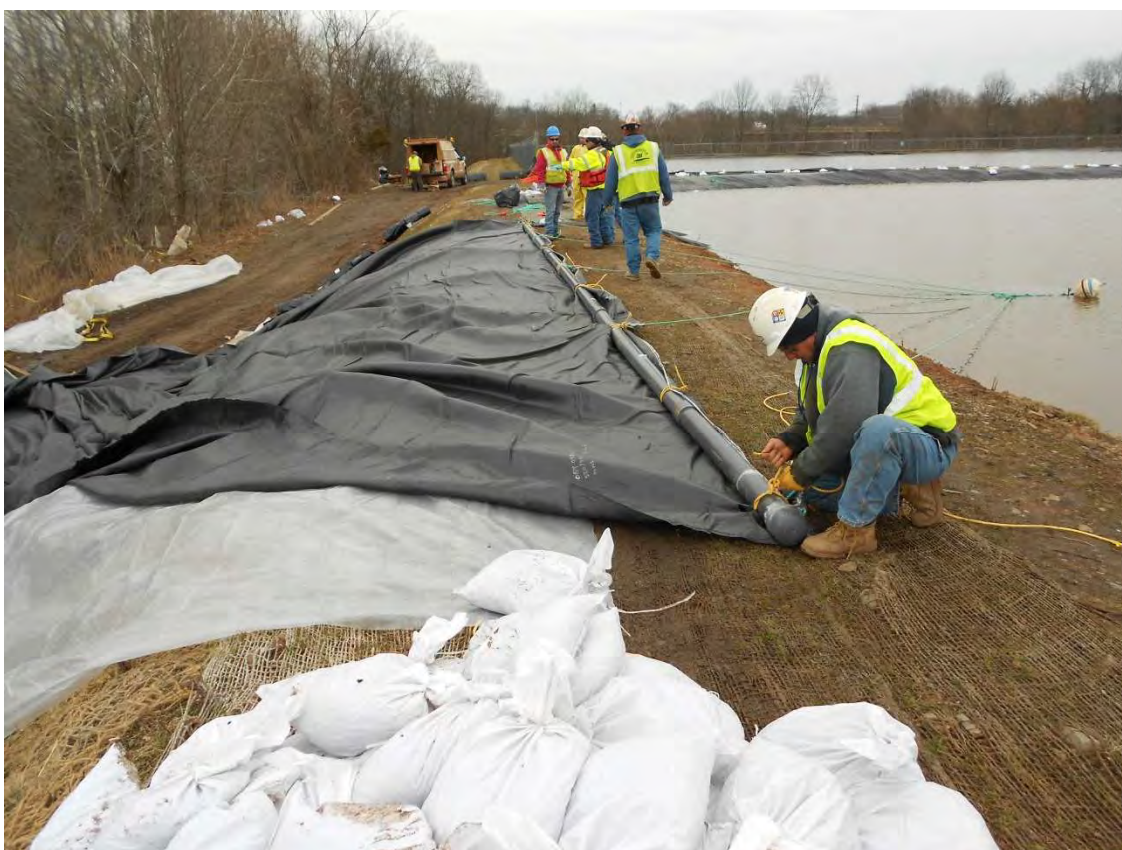
Photograph 8: March 4, 2012 – Attaching third panel to cables for deployment.

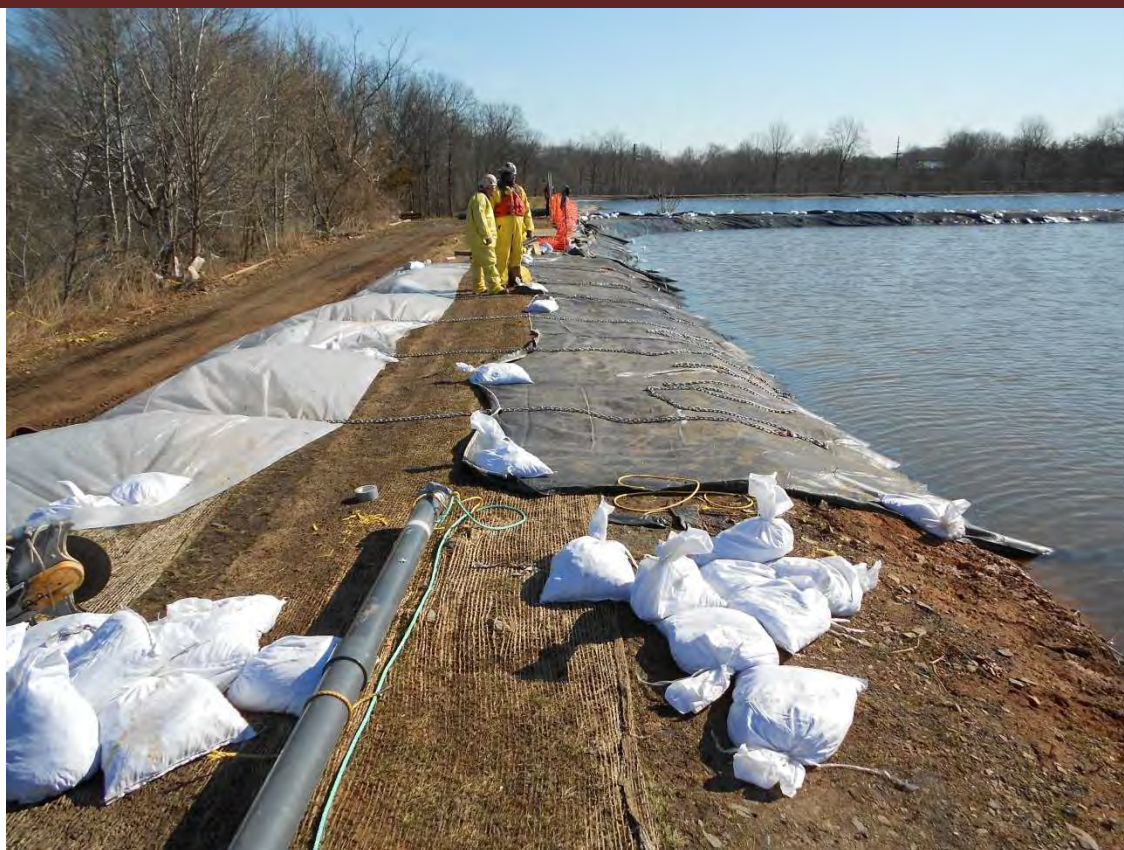
Photograph 9: March 5, 2012 – Third panel in place after installation of ballast chains

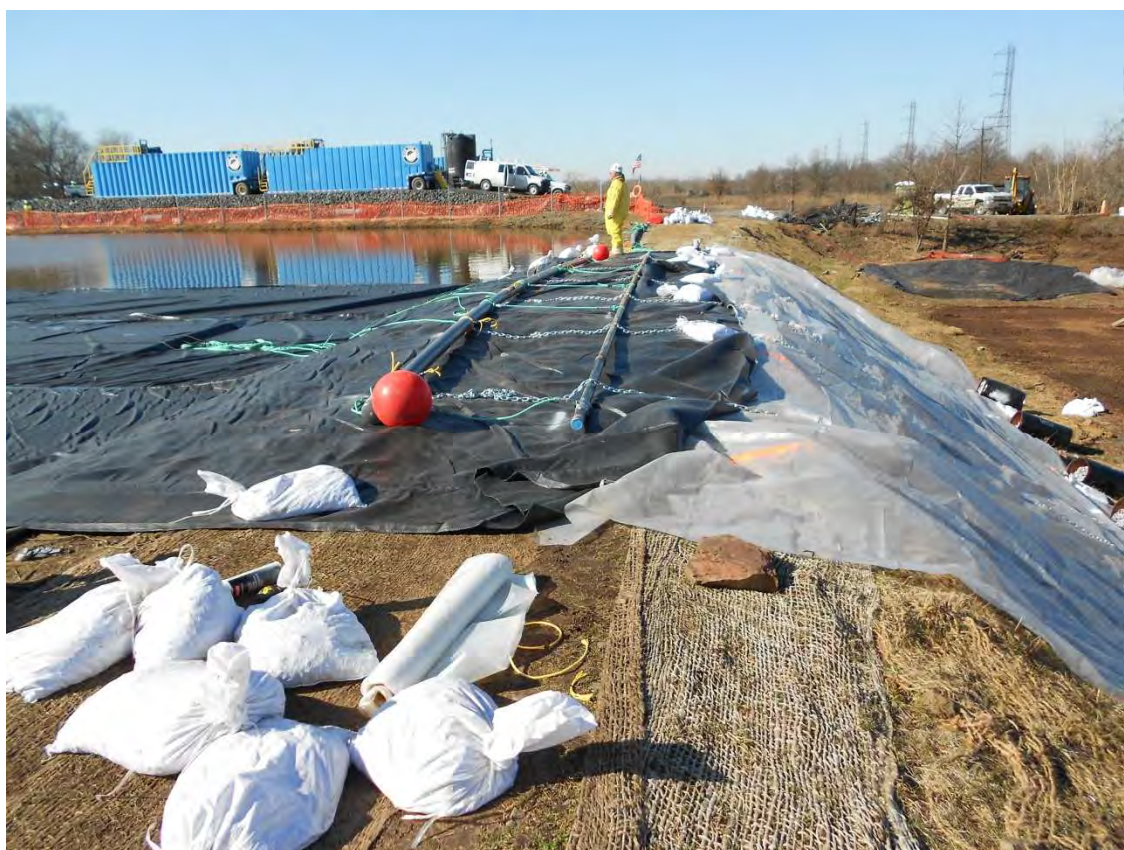
Photograph 10: March 6, 2012 – Deployment of fourth panel

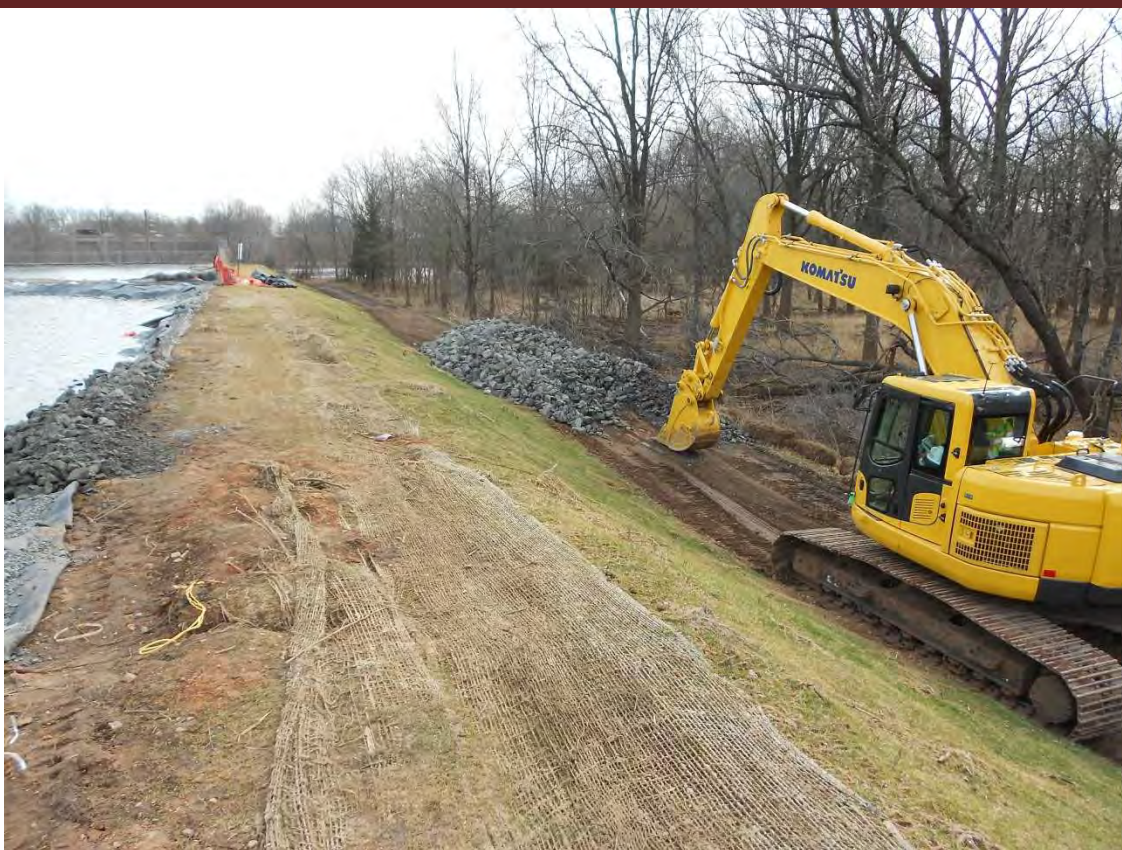
Photograph 11: March 9, 2012 – Placement of rip-rap to anchor perimeter of panels following deployment of all seven panels.

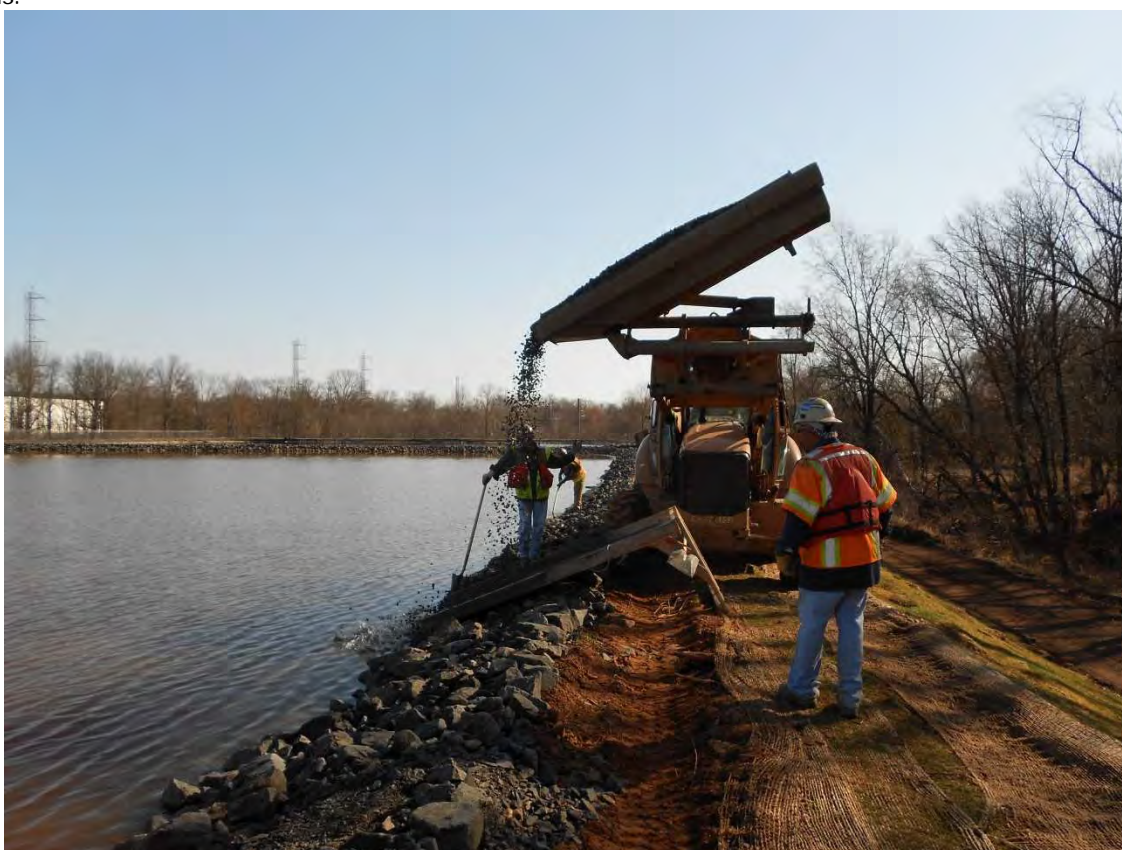
Photograph 12: March 14, 2012 – Placement of $\frac{3}{4}$ -inch stone

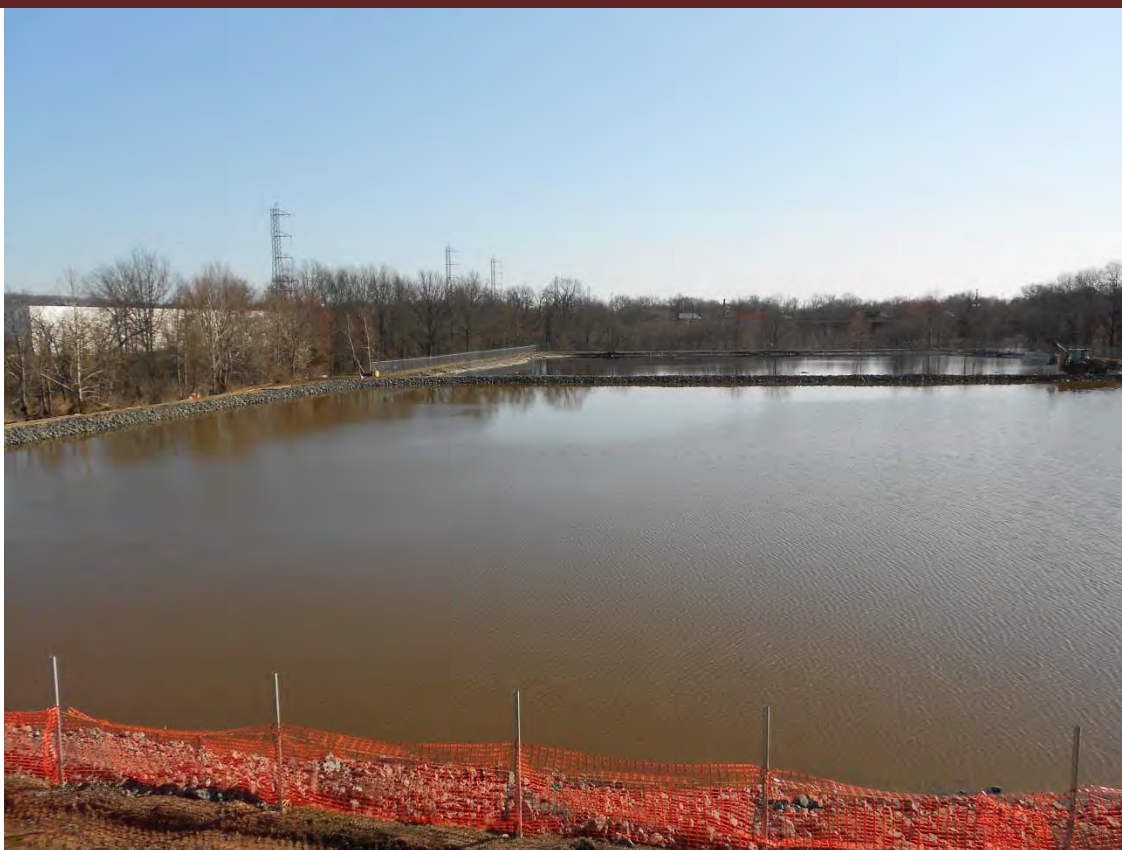
Photograph 13: March 14, 2012 – Impoundment 2 after installation of cover and rip-rap anchor

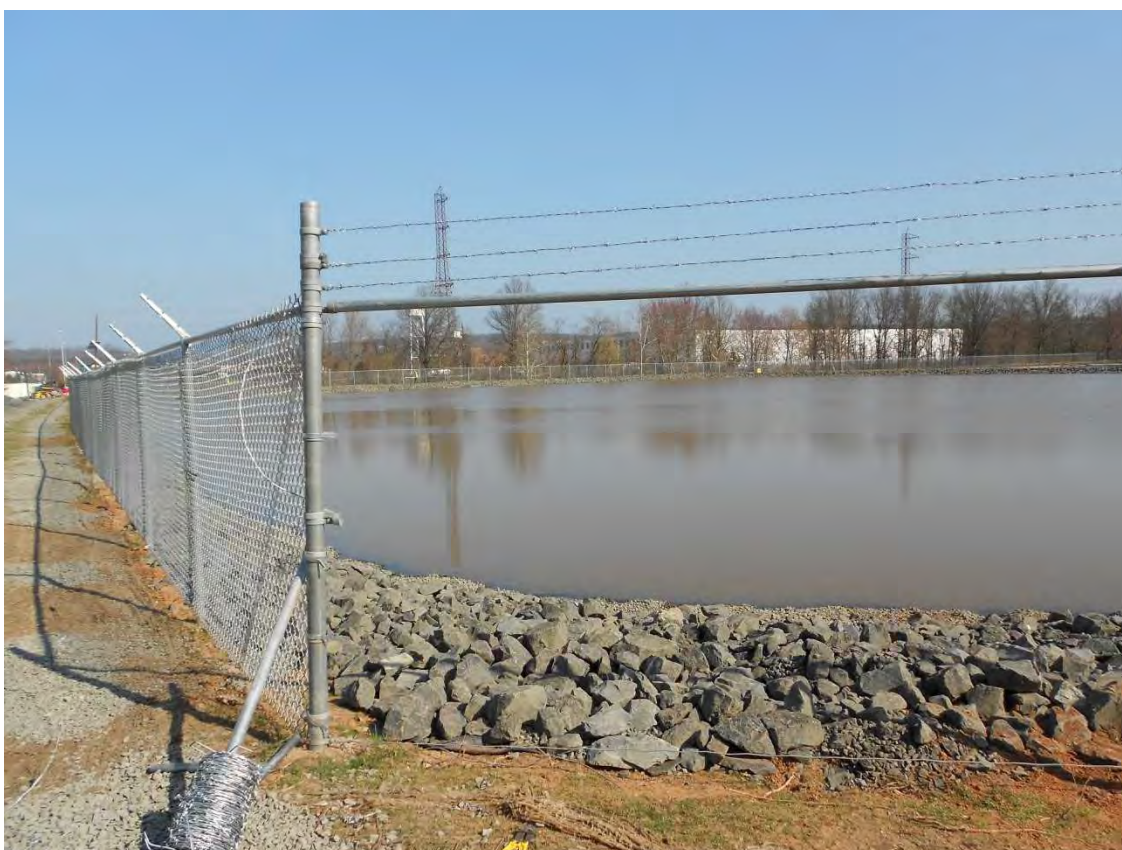
Photograph 14: March 19, 2012 – Restoration of perimeter fence
